**Reserve Fund Plan for  
FALLS RUN COMMUNITY ASSOCIATION  
Stafford County, Virginia**

**COMPONENT DATA AND  
ASSET REPLACEMENT SCHEDULE**

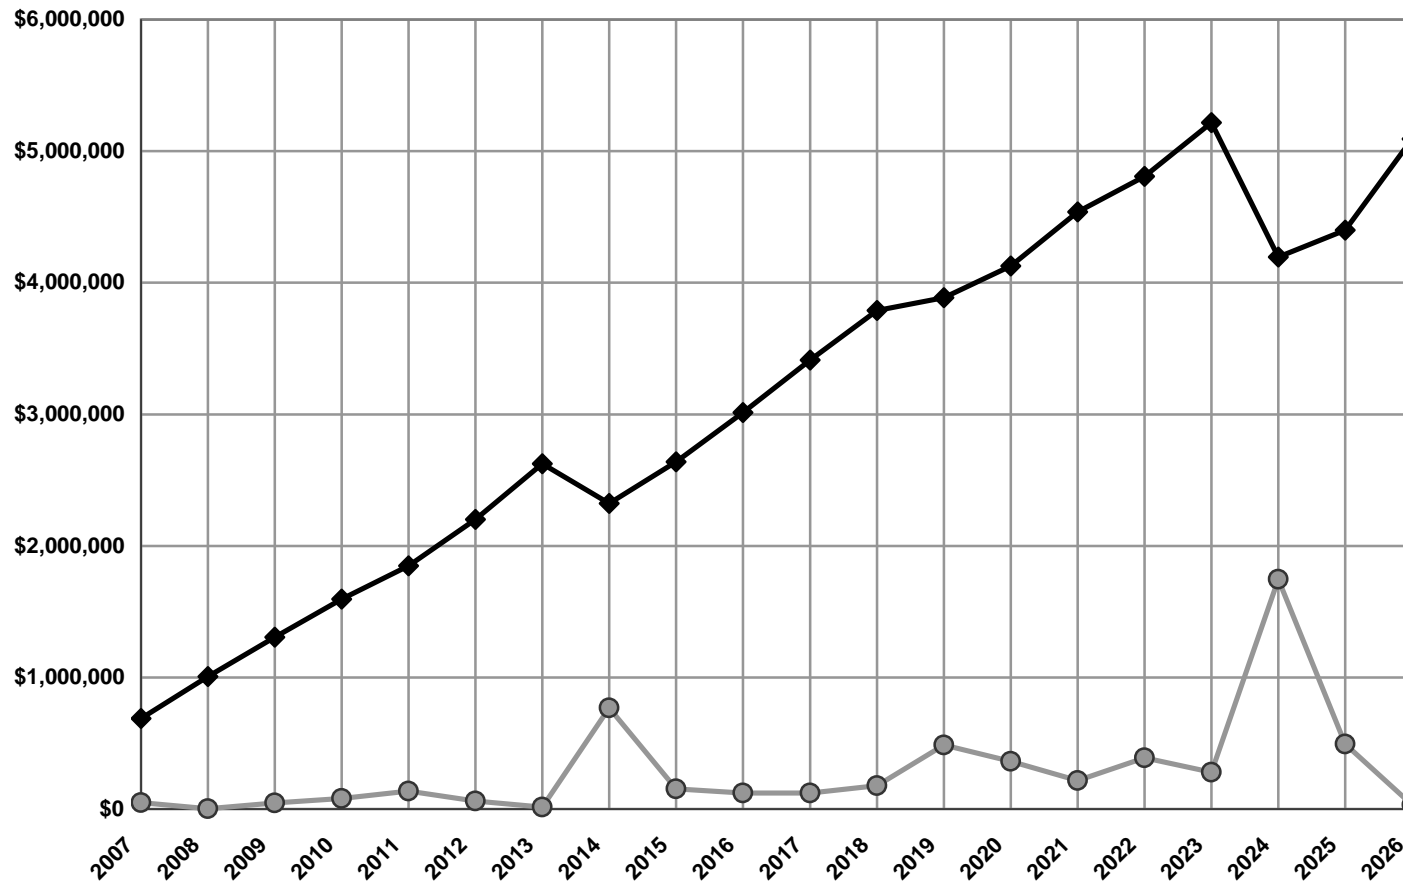
FUNDING ANALYSIS  
CASH FLOW METHOD  
TABLE 3

◆ ENDING RESERVE FUND BALANCE  
● CAPITAL EXPENDITURES

Column 7	<b>Ending Reserve Fund Balance</b> is the result of the beginning reserve fund balance plus the annual contribution, plus interest income, less capital expenditures for the year.
Column 8	<b>Balance to Asset Base Ratio</b> , expressed as a percentage, is the ratio between the ending reserve fund balance and the total asset base for that year. The ratio is useful to the analysts in understanding general financial condition, but there is no standard ratio as each community's condition and complexity varies.

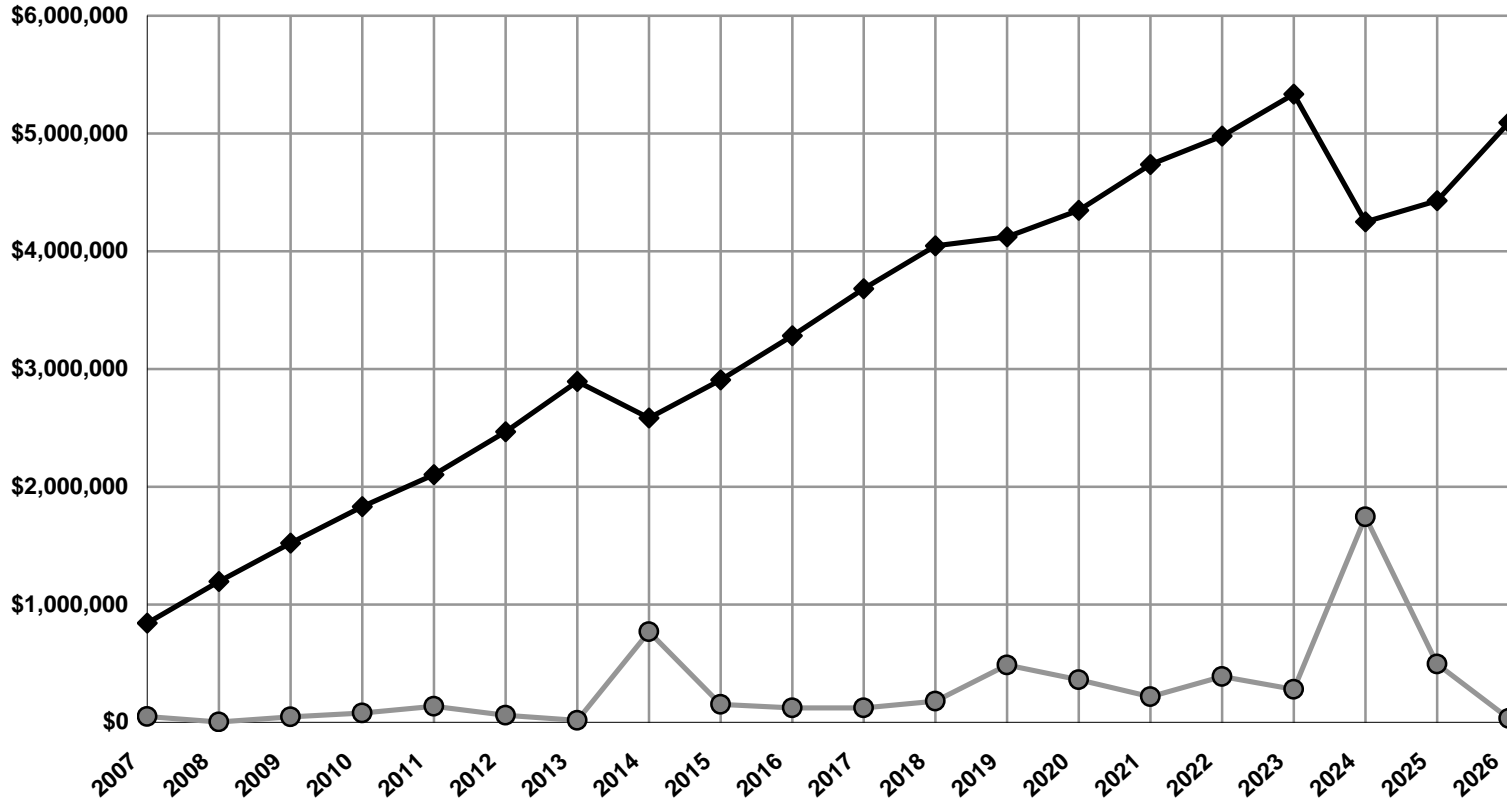
**FUNDING ANALYSIS  
COMPONENT METHOD  
TABLE 4**

◆ ENDING RESERVE FUND BALANCE  
● CAPITAL EXPENDITURES

Table 4 is a yearly list of annual contributions toward each component, which must be made to achieve 100% funding. The reserve fund balance is the balance at the beginning of the study year. The beginning reserve fund balance is applied, proportionately, to each component prior to calculating the yearly contribution for each component. Future costs (inflation) are factored into the replacement cycles. The annual contribution for each year is calculated in the bottom row of the study labeled **Annual Component Contribution Totals**. Interest and inflation are calculated at the same annual rates as the Cash Flow Method (Table 3).
